Article for Association of Facilities Engineering

Infrared Thermography: Recommended Maintenance Practices for the Facilities Engineering Professional

By L. Terry Clausing, P.E.
ASNT NDT Level III IR/T

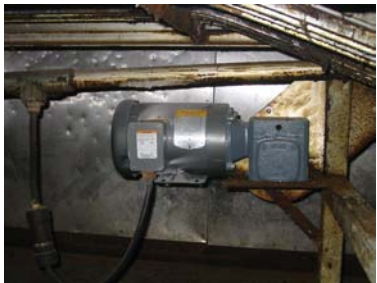
In the photograph (left), the drive motor and gearbox appears to be working properly, but the infrared image (right) the gearbox is clearly overheating, indicating a pending mechanical failure!

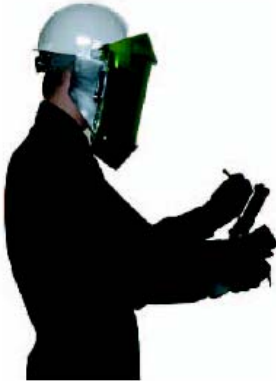
VPF-50

Arc flash is a major concern with electrical systems and NFPA is moving towards requiring all electrical cabinets to be identified and labeled in terms of arc flash exposure risk when the panel covers are removed. Infrared cameras cannot see through metal panels but a new infrared window, the IRISS VPF®-series is now available that can be easily installed in high voltage cabinets. This window, IP-65 rated, allows the interior of the cabinet to be examined without opening the cabinet, enabling a qualified thermographer to perform more frequent inspections quickly and efficiently.

These infrared windows are available in 2, 3 and 4 inch

diameters (2" / 50mm at right) and work with both long and short wavelength infrared cameras enabling the thermographer to maintain a safer distance from the inspected equipment. This minimizes your risk of arc flash exposure, and without locking you into a particular camera manufacturer or service provider, enabling you to achieve improved safety and productivity. Considering their low cost and easy installation, these certified performers (UL approved) greatly enhance the value of your electrical P/PM program by protecting people and profitability.
